Field Service Procedure

Part Number: SP00257

WPU Hard Drive Replacement

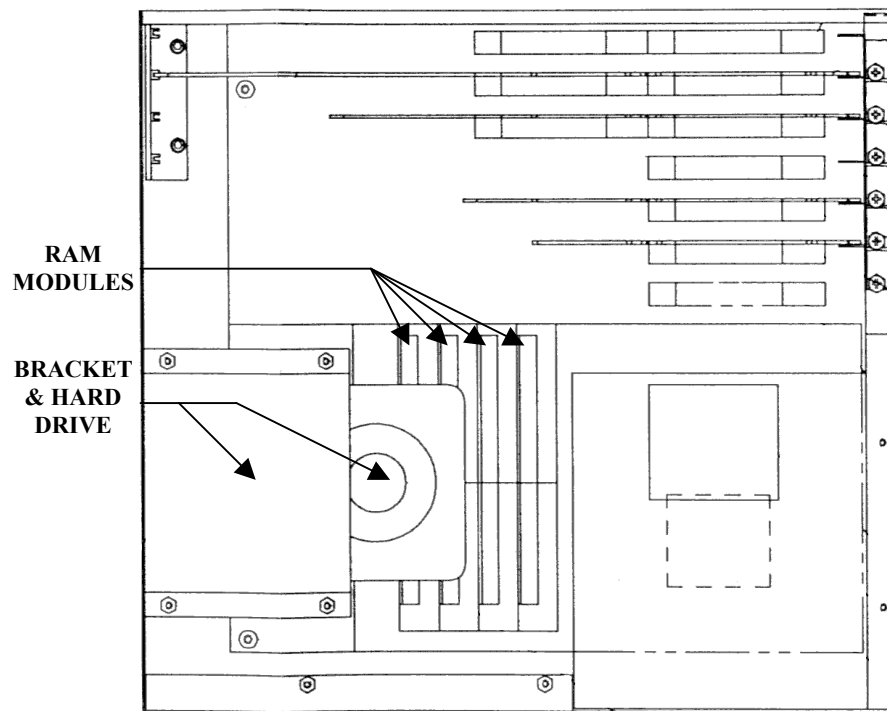
FIGURE 1. WPU Component Location Identification

2. Remove the WPU cover.
3. Locate the hard drive and bracket assembly. Refer to Figure 1.

4. Remove the four Phillips head screws that secure the hard drive to the chassis and very carefully remove the assembly.
5. Disconnect the hard drive data and power cable and place the assembly onto a 1-inch thick foam pad.
